Manhole Inspection Summary

Manhole # S21EE2019MH

Insp Date: **11/17/06 9:59 AM**

Location Address: **5801 CLARKS HILL**

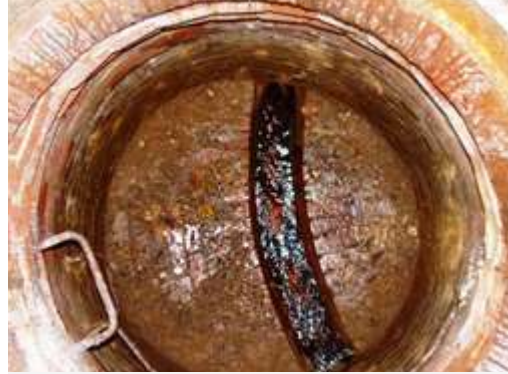
Top View

Bench debris.

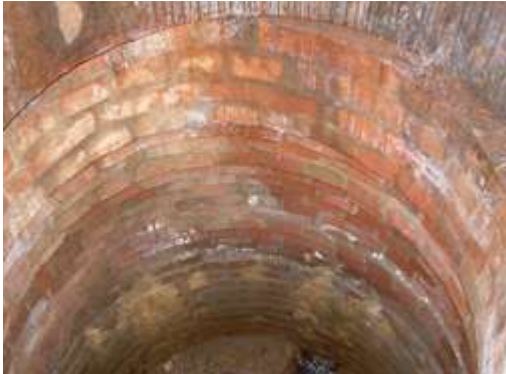
Defect

Frame leaks. Frame offset. Adjustment deterioration and infiltration. Barrel infiltration.

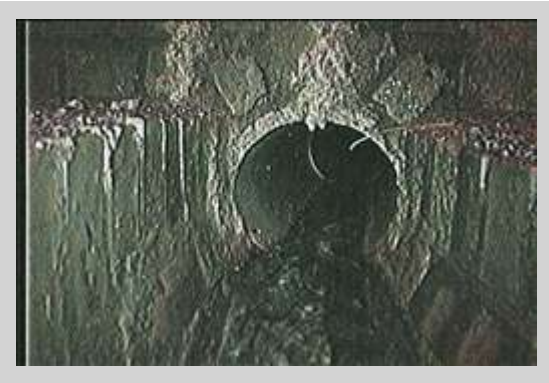
Pipe Out @ 12 O'Clock

Invert Depth: **7.84** (ft.) Flow Characteristics: **Slow**

Deposits: ☒ None ☐ **Mud** ☐ Sludge ☐ **Debris** ☐ Grease

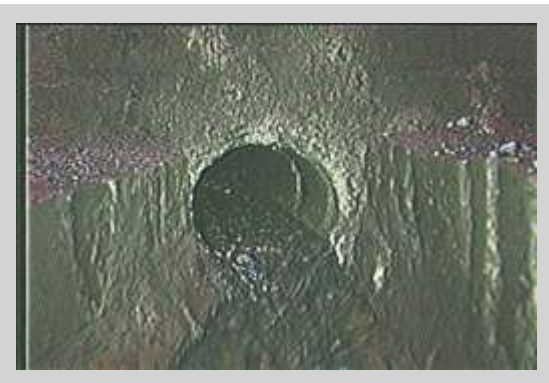
Pipe In @ 4 O'Clock

Invert Depth: **7.78** (ft.) Flow Characteristics: **Slow**

Deposits: ☐ None ☒ **Mud** ☐ Sludge ☒ **Debris** ☐ Grease

Silt Depth: **1** (in.) Deposits Extent: **Light**
